Relevant Research for Bridge Owners

Barry Colford
Chief Engineer & Bridgemaister
18 January 2012

Forth Road Bridge statistics

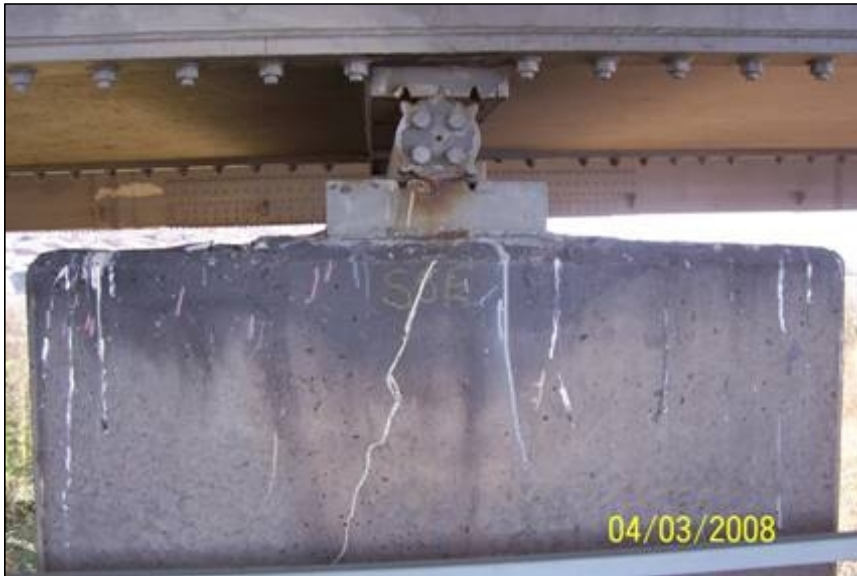
Typical Steel Roller Bearing

- Not free to roll – uneven wear due to stress and/or corrosion
 - Higher stresses in pier than considered in original design
 - Justified by use of cracked section properties but box stresses too high
- Bearings assessed according to BS5400-9-1:1983 and BS EN 1337-4
 - Modern geometrical limits not met
 - Significant codified overstress
- Roller bearing at end of North viaduct near the side tower is near limit of movement range limit

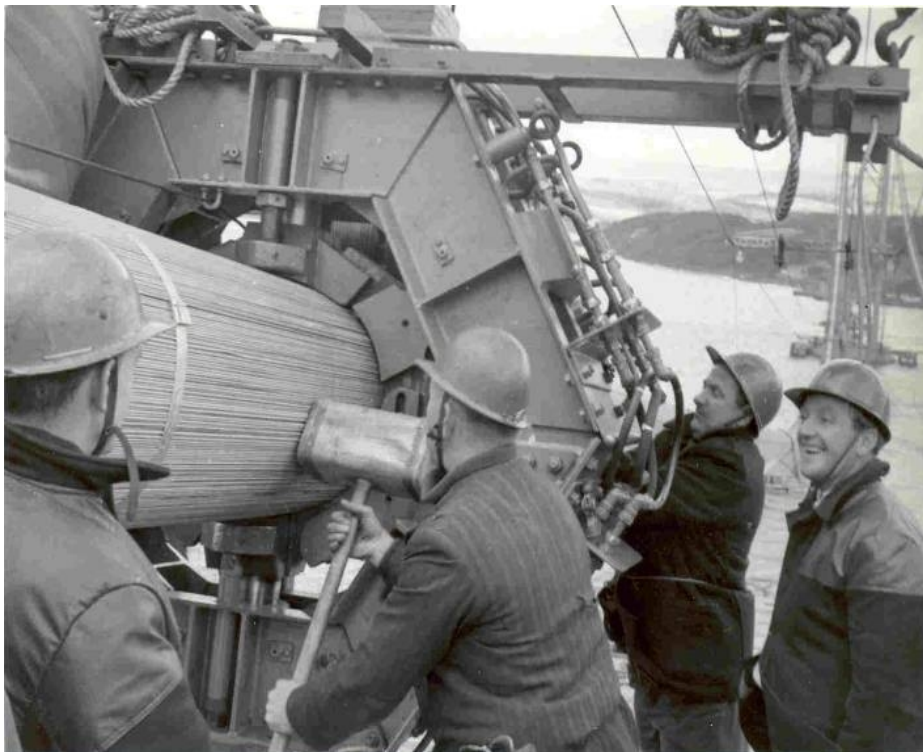
- Traditional corrosion protection: galvanising on each wire, compaction, red lead paste, wire wrapping and painting.
- Cable has been regularly inspected externally and repainted

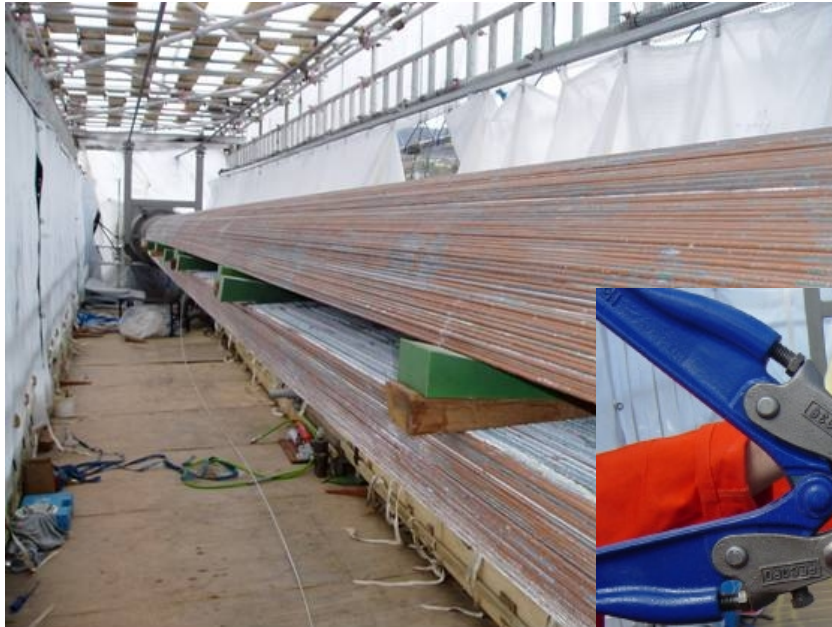
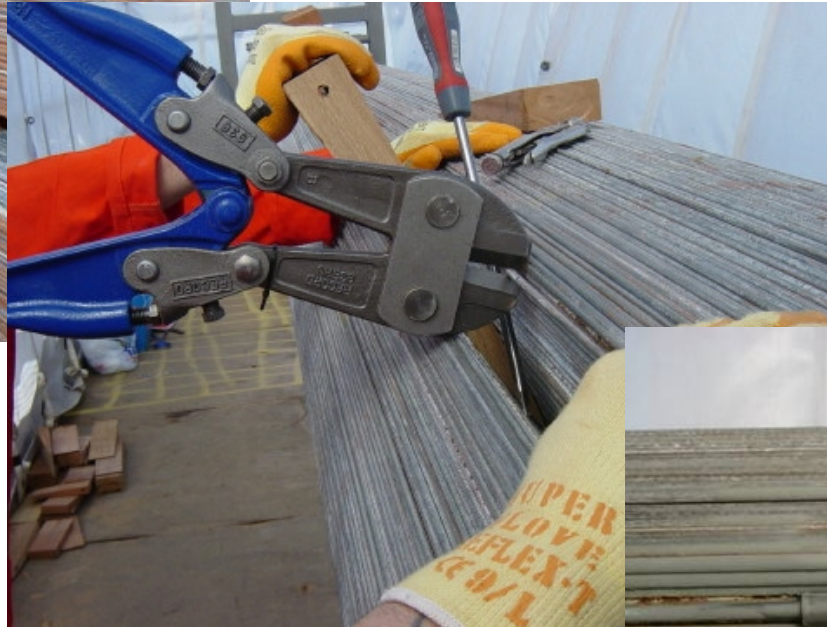
Wedging for inspection

Removal of wire samples

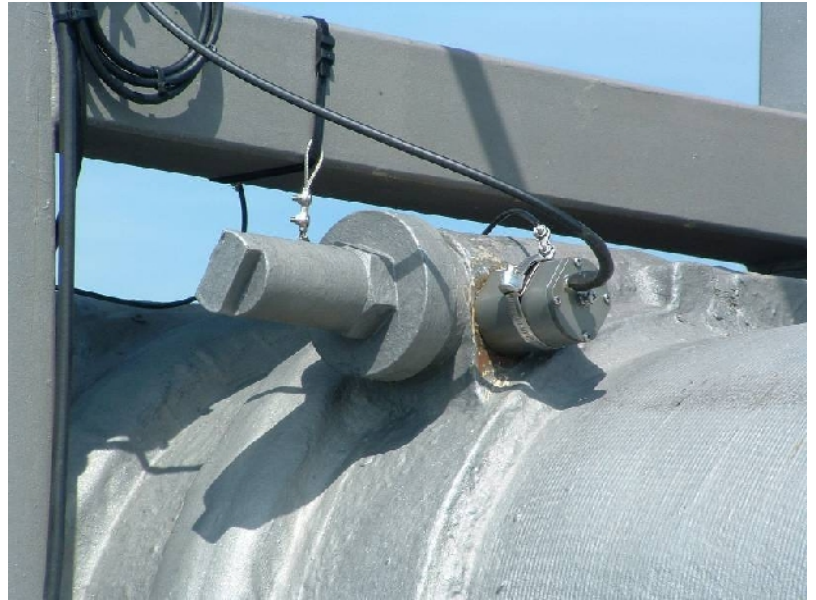
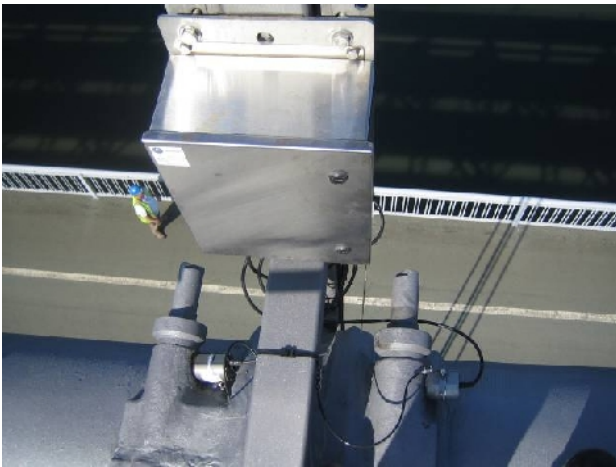
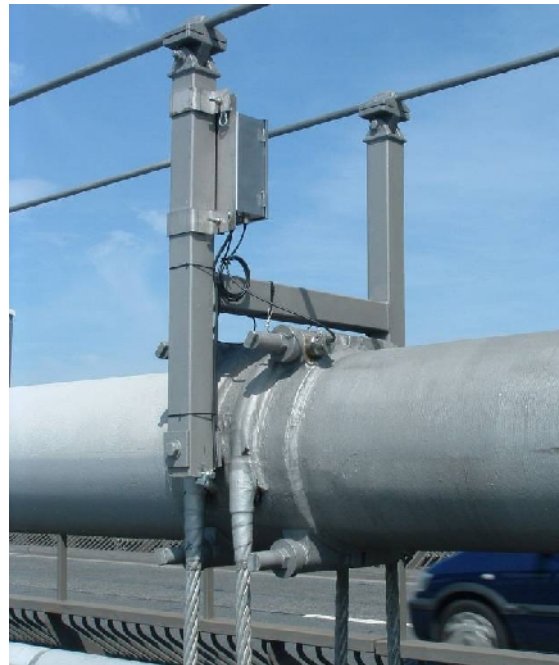
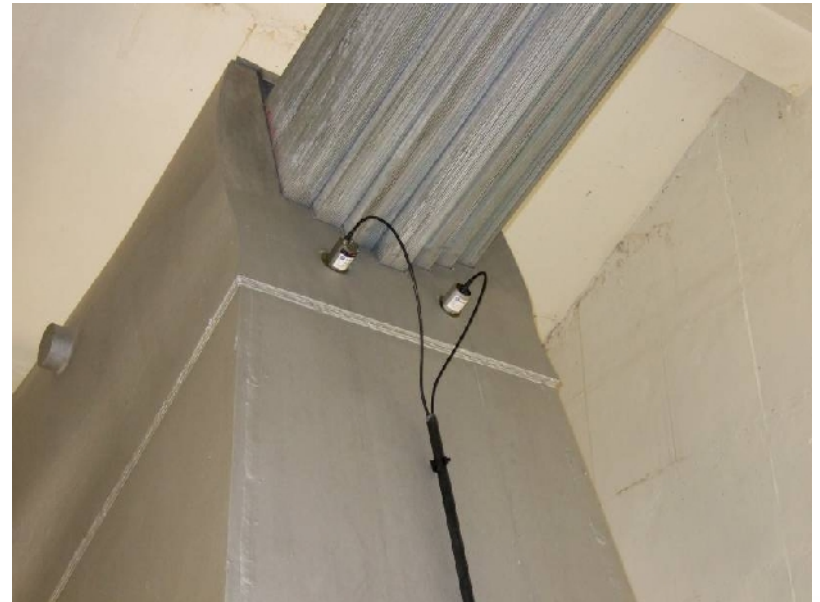
Acoustic monitoring installation

- Internal inspection only looked at a small proportion of wires.
- No guarantee that the worst deterioration has been found.
- Rate of deterioration is uncertain.
- Acoustic monitoring can provide information on the whole cable, and over a long time period.

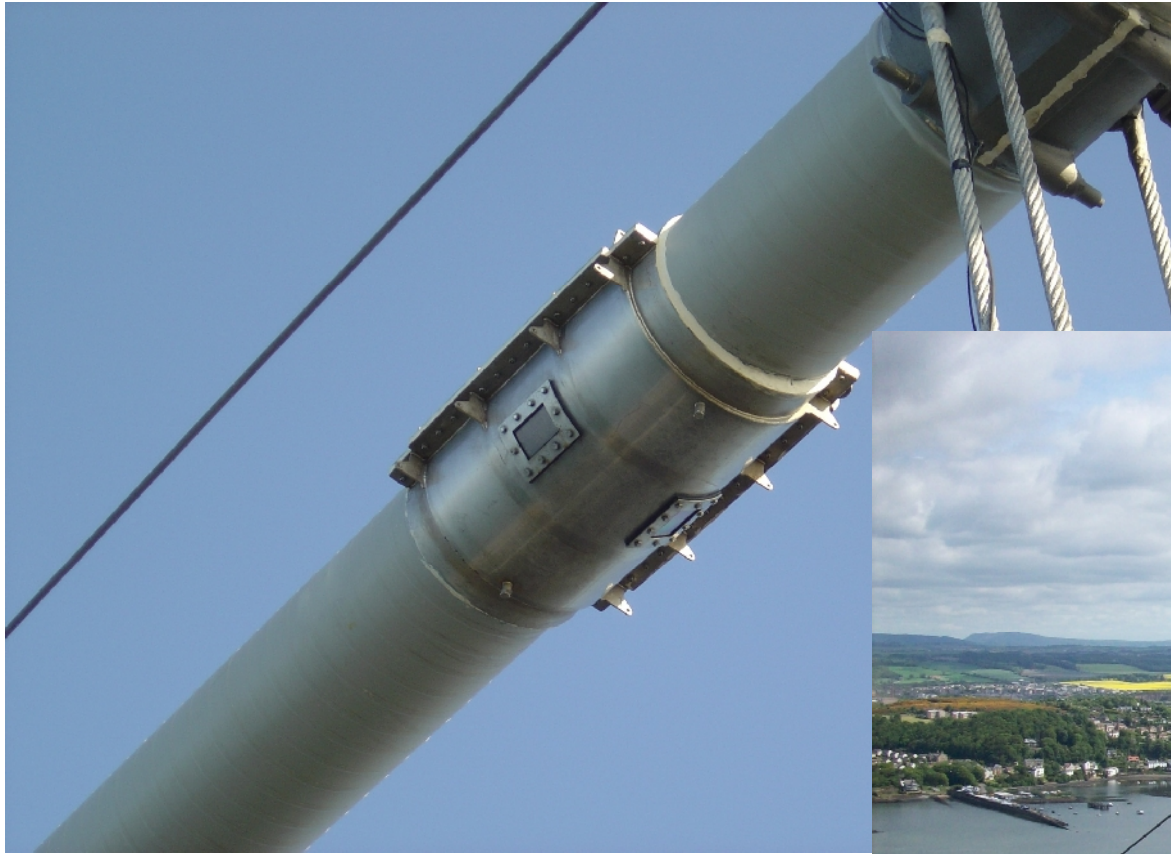
Injection Sleeve

Injection and Exhaust Sleeves

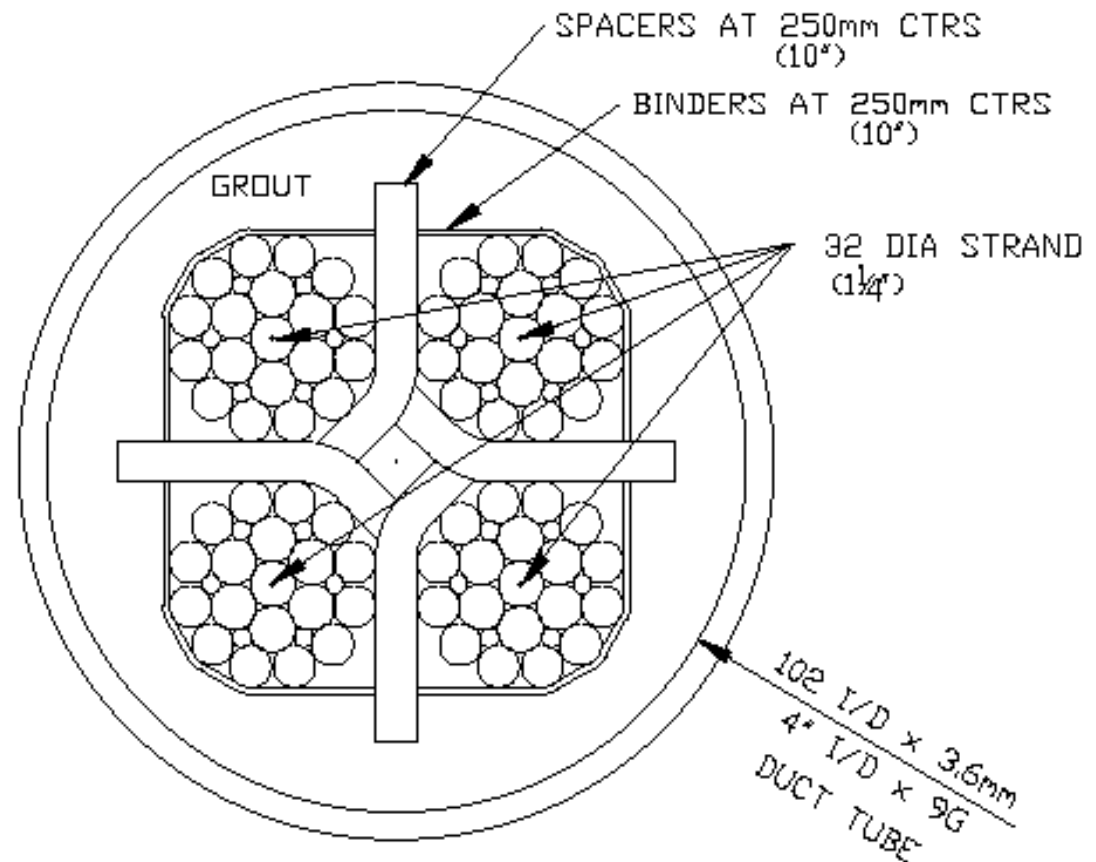
**FORTH ROAD BRIDGE
ANCHORAGE STRANDS**

4No 32 DIA CABLES IN DUCT
(1 1/4")

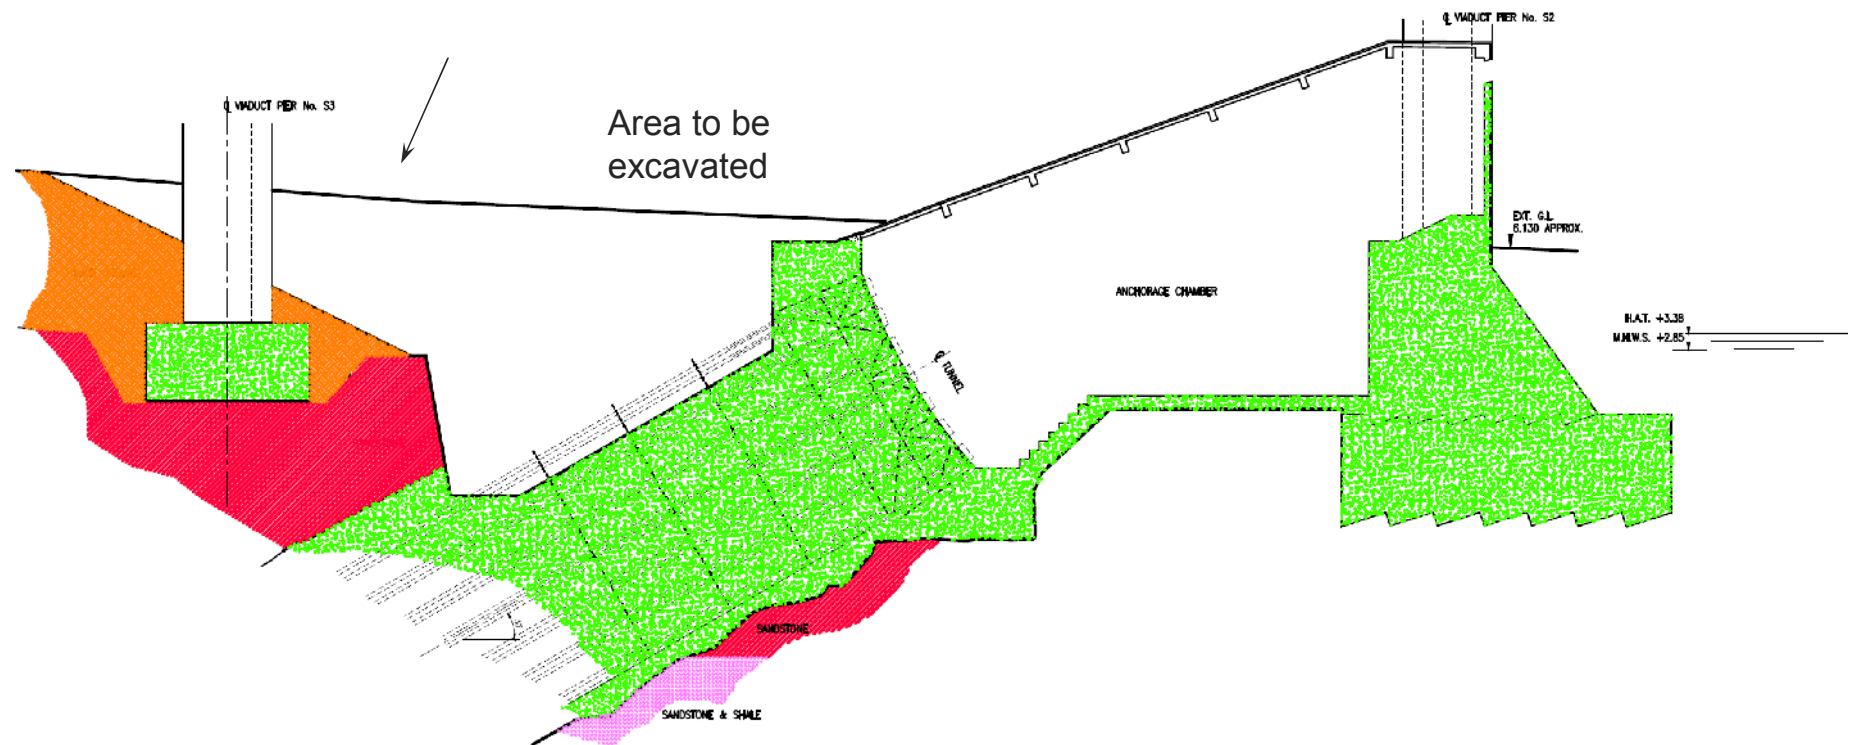
Stage 2 – Excavation

- Rock (sandstone) and concrete
